Repair and Rehabilitation of a Cantilever Beam

B.Jayashree*

Department of Civil Engineering, Vinayaka Missions University, Chennai, India.

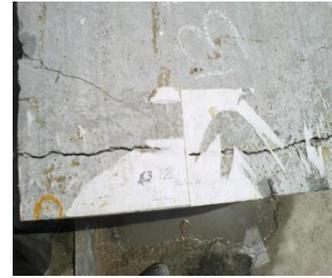
Figure.4.Crack in Beam – Column Junction

Later the crack was found to develop, and to check whether the crack is a live crack or not a paper was stuck on it. While observing that crack it was found that the paper was tearing because the crack was a live crack. Cracks in the beam are shown in figures 4.

Since the crack was developing even more wider of about 6mm in 25 days a serious problem was found in that beam. The Beam was first given support to withstand the heavy load on it. Then the beam was chipped for investigating the cause for that crack.

Analysis: The beam was found to be provided with insufficient development length, the top rod of the beam was terminated after just inserting the rod inside the column for 900mm. This is the reason for the development of the crack. Thus the repair was analyzed.

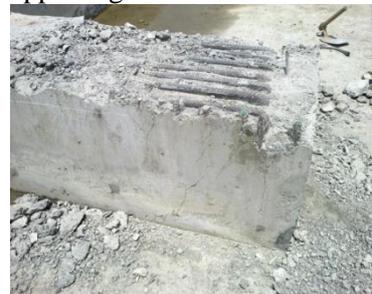
Figure.6. Chipping of Beam

The Beam is chipped to investigate the real cause for the crack. It was found that the beam top rods were not given sufficient development length which is the main reason for formation of crack.
