Experimental optimization on durability of exhaust valves in CI engines

Dr.P.Senthilkumar, R.Pradeep, E.R. Sivakumar

Department of Automobile Engineering, Madras Institute of Technology, Chrompet, Chennai 600044, India

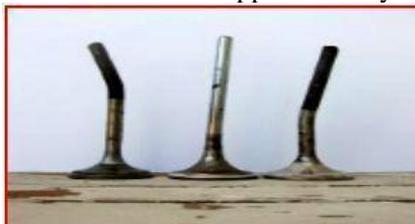
Failed Valve 1: It is known that a valve stem is always experiencing less stress than the valve head portion; the stress levels would be around 18×10^3 KPa over the 2.5 centimeter small face area. However, the stem is also affected by the seating load, which is generally less than 13×10^3 KPa. The above valves were in good condition, with minute wear and corrosion. But, the stem was bowed approximately 25° as shown in figure.1

Figure.1. Failed Valve 1

This kind of failure is not of regular or series nature, but may probably be caused by clash with the cylinder. A few engines enclose tight tolerances where the valves actually extend as much as necessary to enter the combustion chamber so they ram with the piston.

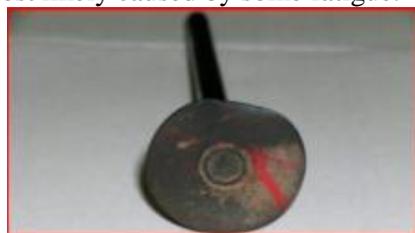
Failed Valve 2: Valve heads are subjected to drastic loads weighing around 1.5 tonnes. Also they are subjected to extreme thermal stresses, with temperature range of up to 1200°C across a 2.5centimetre diameter face. And thus a smallest alter in seating may possibly cause failure.

This valve seemed to be older and well used, even though there was only very little development of corrosion on the valve. The mere damage was the absence of small flake in lip of the valve head. This damage was hard to decide, and guessing it would most likely caused by some fatigue.

Figure.2. Failed Valve 2

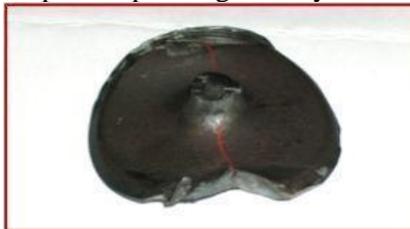
Failed Valve 3: This valve had various points of breakup. The three key points of damage were rough projections of a valve face cut out from the stem area, an upward bent lip pressed towards the stem and in the end the absence of stem itself. Also there were several cuts within the sides of the valve, which would be some hard collapse and not a cause of failure.

The stem, cut out off the face also had sharp angles. And thus the point of damage obviously shows that the failure was not of slow progress, but perhaps a sudden and violent collision. Eventually, the stem looked almost like a twisted staircase with large fractured planes, pointing radially from the centre.

Figure.3. Failed Valve 3

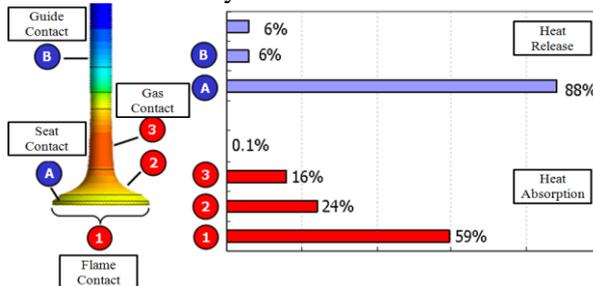
Simulation of failure: The failure juncture of exhaust valves were studied and applied in simulation with the thermal load to the valve dynamic stress. As a result, the heat transfer percentages of each area are shown in above. The heat generated by exhaust gas is the main source to the valve's thermal loading, 60% of the heat generated is absorbed at flame contact side i.e. the underneath of valve resulting in thermal shocks ending in failure.

Also the 20% of heat is absorbed at the upper surface of the valve and 16% is at the valve neck region. Because of this in-desirable heat release at the face of valve, the temperature level on the seat contact (A) is inferior to the valve seat but still they face the exhaust gas directly. It can be seen in the above figure that, the maximum temperature is at the valve neck where the failure is occurred. The results of exhaust valve temperature analysis were applied to thermal load of stress analysis.

Figure.5. Simulation of failure

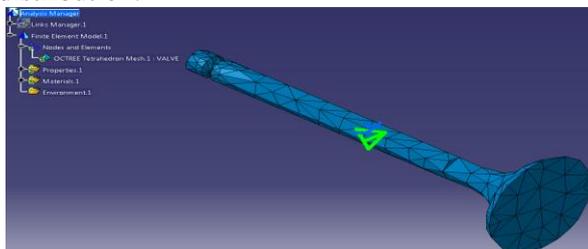
A meshed exhaust valve model: A well-known method before working on any kind of analysis is meshing. Meshing (creation of grid-points called nodes) is the most important element in any of the computer simulations,

since it can show drastic alterations in results with perfection. The mesh results are calculated by computing the tool, which does it with relevant governing equations numerically at each node of the mesh.

In all this simulation process, an OCTREE tetrahedron mesh was applied with; Mesh size: 8mm and Absolute sag: 1.138mm.

Combustion pressure of 140 bar with temperature of 800°C was considered for all the simulation analysis to check the temperature /stress distribution.

Figure.6. An OCTREE tetrahedron meshed valve for simulation

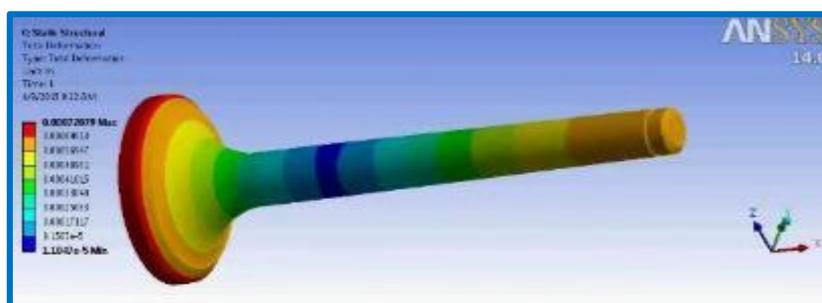
Thermal analysis - coated with Stellite (Cobalt-Chromium alloy): While observing the thermal ability of the coating, it was not bad until it reached the set value, when the temperature was increased; it was found that this Stellite coat loses its ability to adhere with the valve material, resulting in failure of coating due to unbearable thermal stress.

But it was quite good to see the deformation value of 0.00072079mm that was really better than general composition sequences.

It may be due to the physical properties of stellite (non-magnetic and non-corrosive) itself, and little deformations were noted only at contact areas i.e., in valve seat, guide groove, that's because of lesser cross-section at the groove area that has been provided to seat the valve lift.

Figure.7. Simulation result of valve coated with stellite (cobalt-chromium alloy)

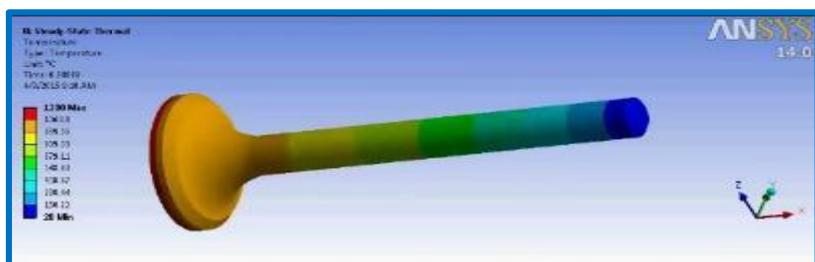
Thermal analysis - coated with Nimonic (Nickel-Cr. alloy): While it was the result of Nimonic coating, it seemed to be just opposite to behaviour of stellite in case of thermal ability (upto 1090°C).

Nimonic was well enough to compensate thermal stress and sudden temperature raise, but deformed bit more than others.

Figure.8. Simulation result of valve coated with Nimonic (nickel-chromium alloy)

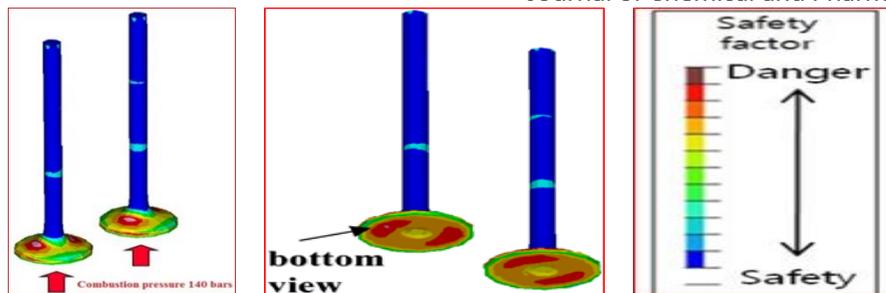
Thermal analysis - coated with DLC (Amorphous carbon): Since it was difficult to apply DLC's properties in ANSYS, it was done with ABAQUS CAE for fine results of simulation.

When looking at thermal mapping, it was clear that this coating was able to withstand higher temperatures with good thermal energy distribution even at high temperature range.

After looking the results of DLC's thermal distribution, having better values than other types, it was another added feature of having a very low deformation than another's that were overviewed.

It had a merely less value below 6.2115×10^{-5} mm even at peak mode of 140 bar, only few areas are dragging the deformation as seen in the figure.

These values show that DLC can be less resistant to wear, and possibly protect the valve mechanically.

Figure.9. Simulation result of valve coated with DLC

Finally after replicating different combinations of coatings that was analyzed, it was better to stay with a DLC coating which is superior to others since it showed better performances in durability of the valve and a good resistance to wear that which is very important in case of a diesel engine.
