Repair and Rehabilitation of a Cantilever Beam

B.Jayashree*

Department of Civil Engineering, Vinayaka Missions University, Chennai, India.

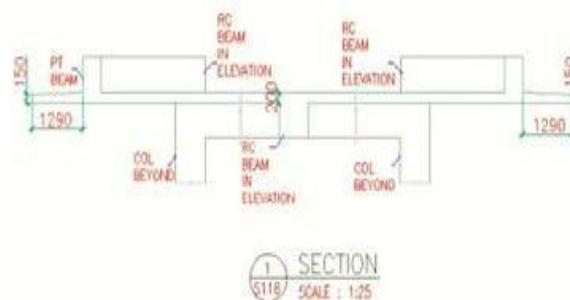
Figure.2. Section

Cantilever Beam: The Beam that is taken for my study is a cantilever beam of length 3.12m, at the free end another beam of 14m length is resting on it from both the sides. The plan and section of the beam is shown in the figure 1 & 2. The beam was provided with 450mm x 900mm size and 7 rods of 25mm diameter and 12mm at 6" stirrup spacing was provided. The beam was then concreted and left for curing; later when deshuttering was done a small hair line crack was found near the Beam-Column junction.

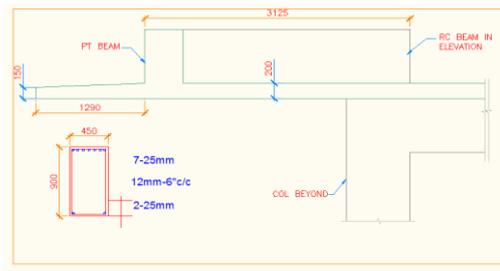
Figure.3.Beam Reinforcement

Analysis: The beam was found to be provided with insufficient development length, the top rod of the beam was terminated after just inserting the rod inside the column for 900mm. This is the reason for the development of the crack. Thus the repair was analyzed.

The Beam is chipped to investigate the real cause for the crack. It was found that the beam top rods were not given sufficient development length which is the main reason for formation of crack.

The rods of Beam were lapped as per requirement and the rods were welded for strengthening of the rods. The two Beams are connected for counter balance as the crack are formed in both beams. The rods of the existing beam itself are extended for counter weight purpose.
